**DEPARTMENT OF TRANSPORTATION****DIVISION OF ENGINEERING SERVICES**

Office of Structural Materials

Quality Assurance and Source Inspection

Contract #: 04-0120F4Cty: SF/ALA Rte: 80 PM: 13.2/13.9File #: 69.28**WELDING INSPECTION REPORT****Resident Engineer:** Pursell, Gary**Address:** 333 Burma Road**City:** Oakland, CA 94607**Report No:** WIR-004942**Date Inspected:** 14-Dec-2008**Project Name:** SAS Superstructure**OSM Arrival Time:** 630**Prime Contractor:** American Bridge/Fluor Enterprises, a JV**OSM Departure Time:** 1530**Contractor:** Zhenhua Port Machinery Company, Ltd (ZPMC), Changxing Island **Location:** Shanghai, China**CWI Name:** Sun Wei**CWI Present:** Yes No**Inspected CWI report:** Yes No N/A**Rod Oven in Use:** Yes No N/A**Electrode to specification:** Yes No N/A**Weld Procedures Followed:** Yes No N/A**Qualified Welders:** Yes No N/A**Verified Joint Fit-up:** Yes No N/A**Approved Drawings:** Yes No N/A**Approved WPS:** Yes No N/A**Delayed / Cancelled:** Yes No N/A**Bridge No:** 34-0006**Component:** OBG & Tower**Summary of Items Observed:**

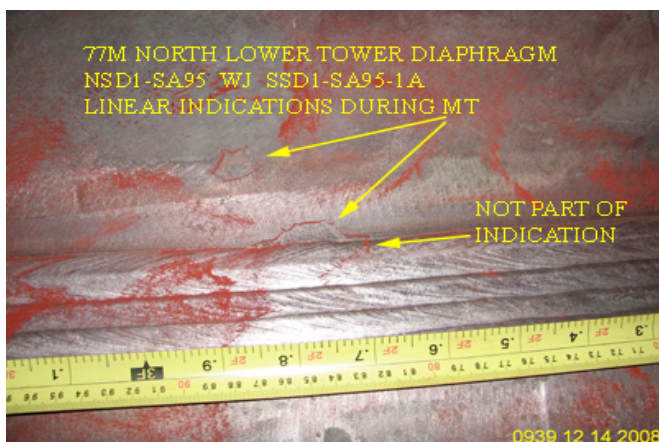
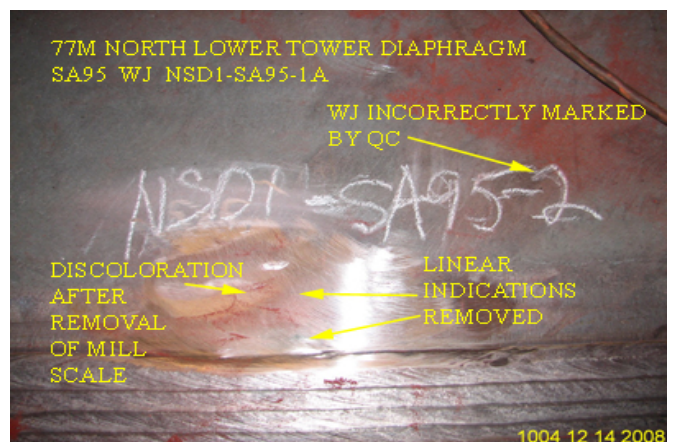
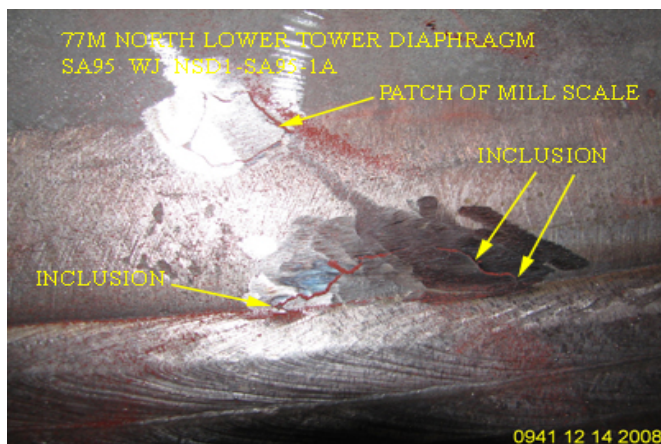
The QA Inspector randomly observed ZPMC NDT Technician Xu Hai, utilizing the MT Method to perform a final MT examination on the cover pass on a butt splice on 77M Lower Tower Diaphragm at WJ's NSD1-SA95-1A and NSD1-SA95-2A. Mr. Xu and the QA Inspector observed 2 separate linear indications in the base metal adjacent to WJ NSD1-SA95-1. A ZPMC helper ground the area which included both indications, to a depth of slightly less than .25mm. Mr. Xu performed MT after the area was ground and the indications appeared to have been removed.

The upper indication appeared to be a small patch of mill scale and the lower indication appeared to be some kind of inclusion line and neither indication appeared to be associated with the welding. There appeared to be no indications after the rework and ZPMC QC accepted WJ NSD1-SA95-1A and NSD1-SA95-2A. The attached photographs provide additional detail.
